New Generation Runway Visual Range (RVR) Final Operational Test and Evaluation Report: Volume I

July 1996

DOT/FAA/CT-TN95/32-I

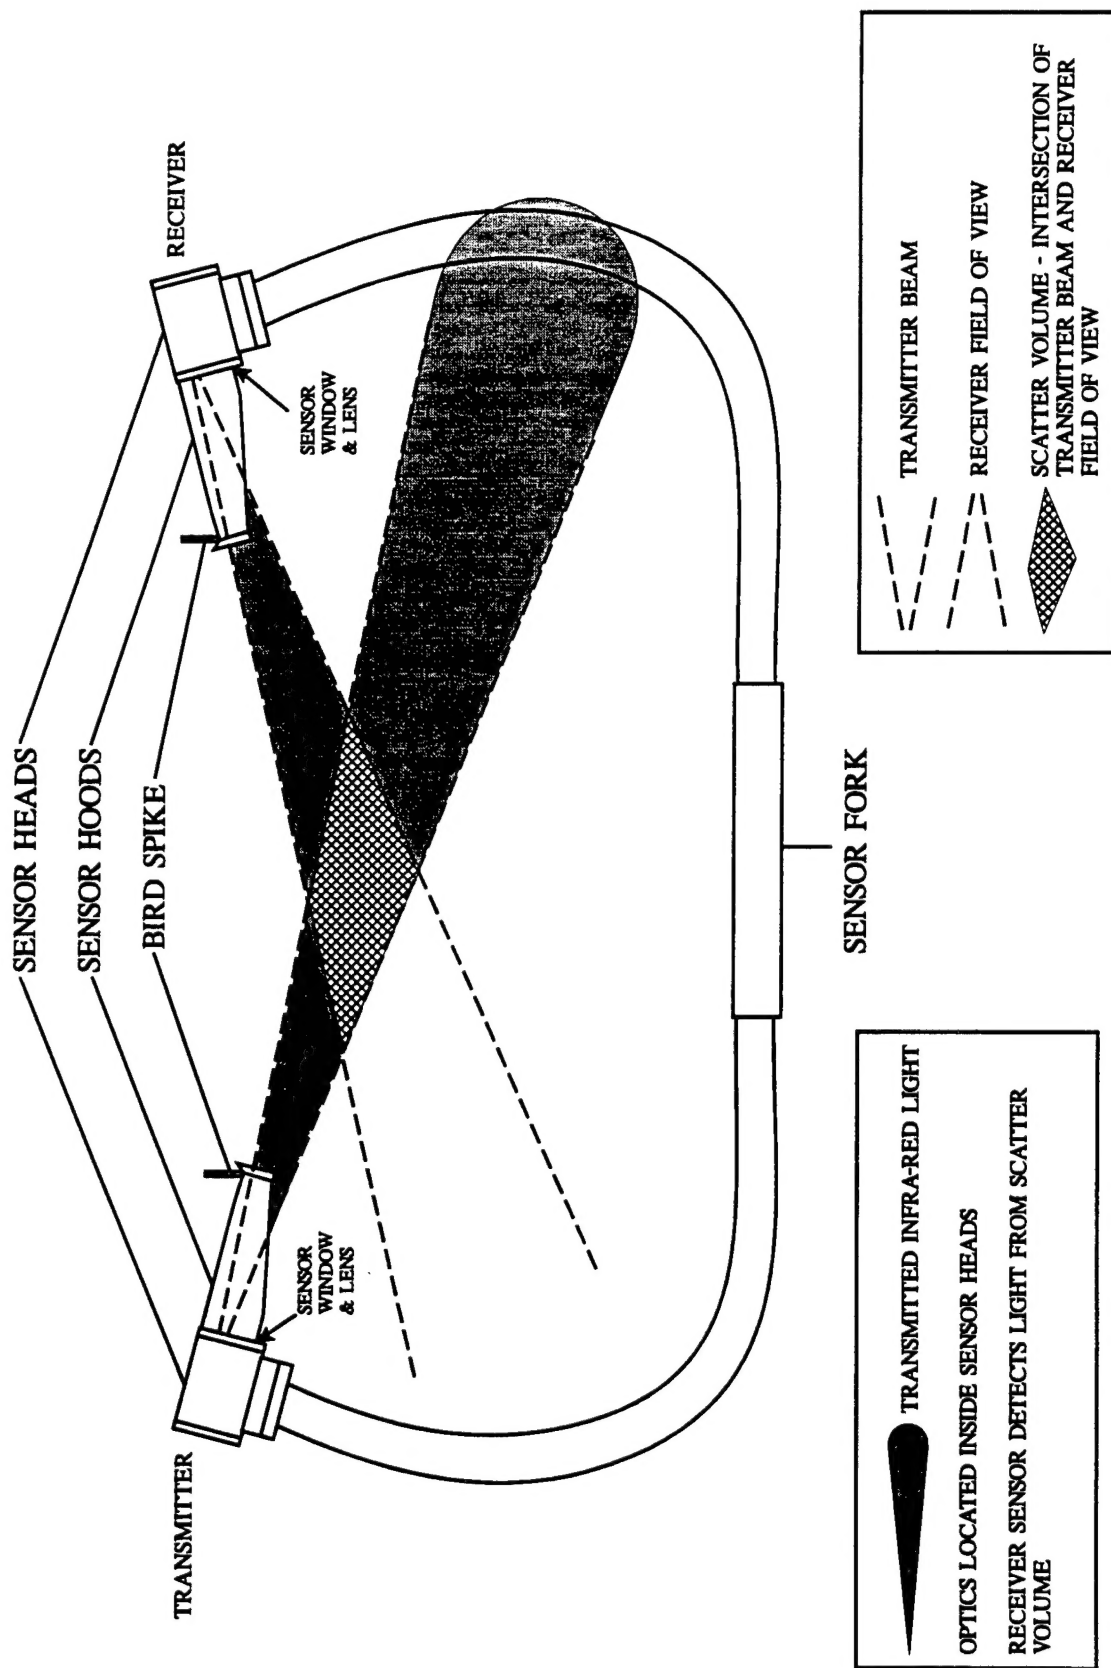
FIGURE 1. LOOK-DOWN VISIBILITY SENSOR COMPONENTS

"Window Signals" originating from the RVR's window contamination detection circuitry were found to be adversely affected by precipitation hitting the lens or "window" (figure 1) of the VS. These signals are actually voltage levels which are proportional to the amount of contamination detected on the sensor lens. Window contamination includes any substance such as snow, water, dirt, etc., that might strike or collect on the sensor window. Effects of precipitation striking the sensor window ranged from errors in extinction coefficients to sensor shutdowns. Because of shutdowns, it was necessary to disable the software modules involved in contamination correction. This effectively eliminated a major functionality of the system.
